MIDDLE HEAD

Conservation Management Plan – Inventory Descriptions

| ITEM DETAILS | | |
|---|---|---|
| Name Of Item School of Military Engineering (later 10 Terminal) Building 7 | | |
| Location Middle Head Rd, Middle Head | SHFT Bldg No 10 Terminal: 7 | Defence Bldg No 7 |

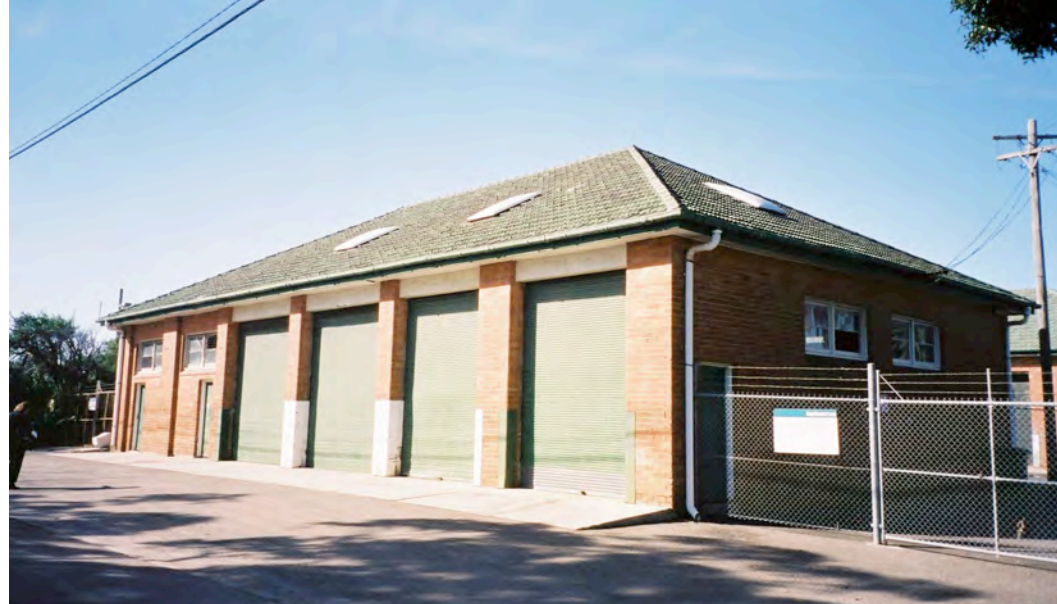
Current view of north façade of Building 7 (Photo: Robertson & Hindmarsh Pty Ltd, 2006)

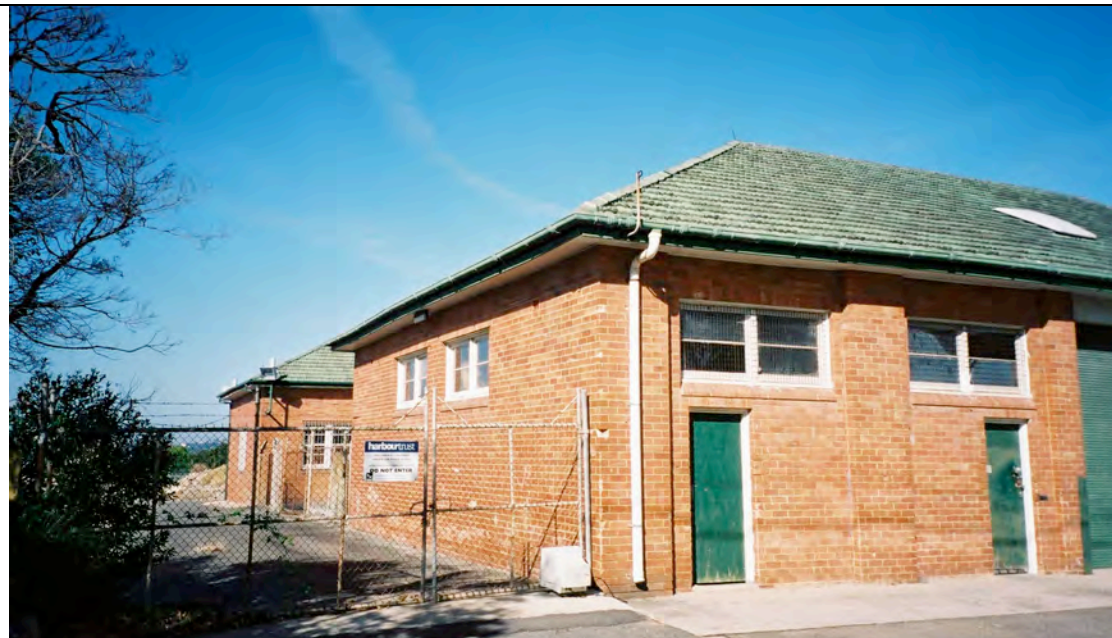
Current view of east façade of Building 7, with Building 6 in the background (Photo: Robertson & Hindmarsh Pty Ltd, 2006)

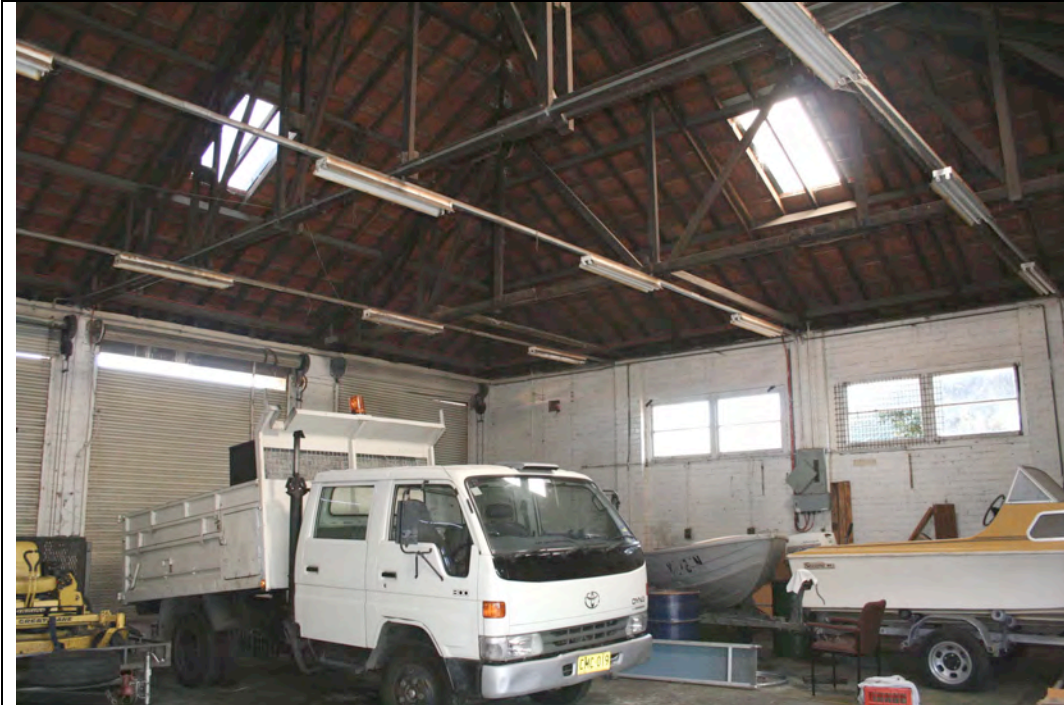
Current view of interior of west room of Building 7
(Photo: Robertson & Hindmarsh Pty Ltd, 2006)

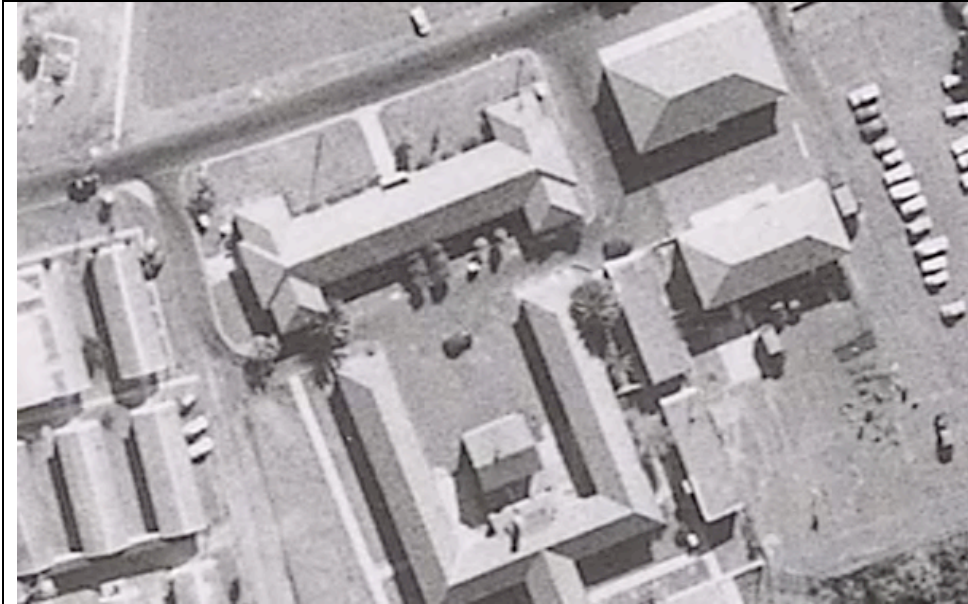
This enlargement from the 1961 aerial photograph shows the layout of large, bare paved areas surrounding Building 7 (1961 aerial photograph courtesy SHFT)

Aerial photographs dating from the 1960s show the layout of the paved areas around the building and indicate the transport-based usage of the building.

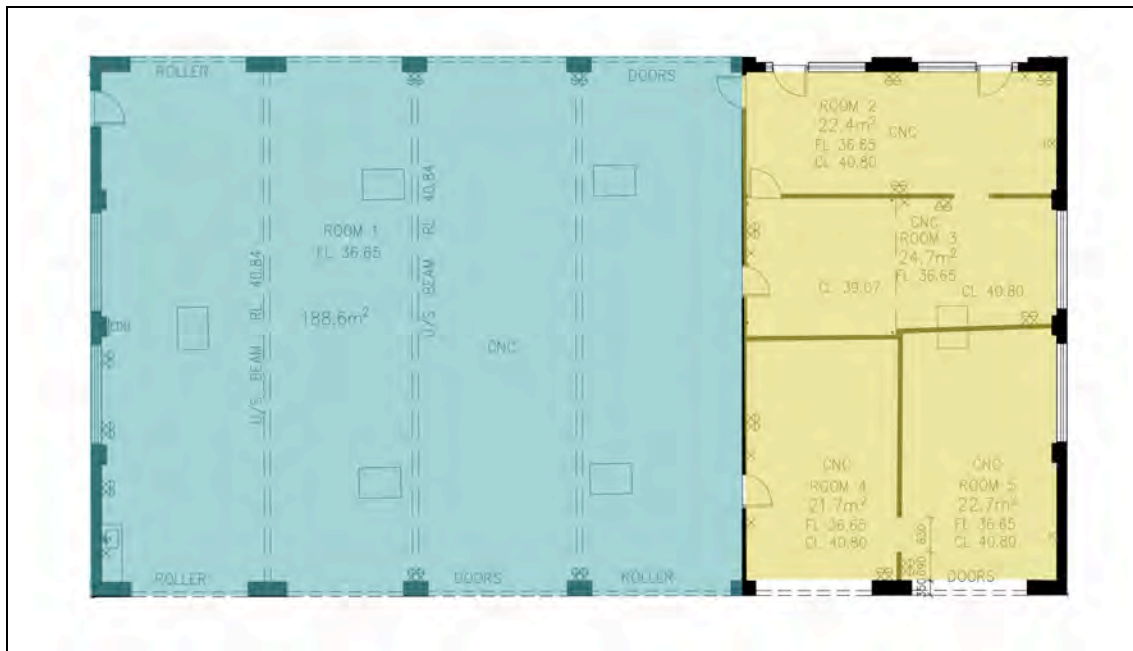
Zones

Retain the surviving volumes in the areas shaded blue. Ideally a single volume should be re-instated in each of the areas shaded yellow.

Re-instatement of the two large original spaces.
